**Fire Risk  
Assessment  
review 2021**  
Austin House  
Walsall  
WS4 2AF

4<sup>th</sup> June 2021

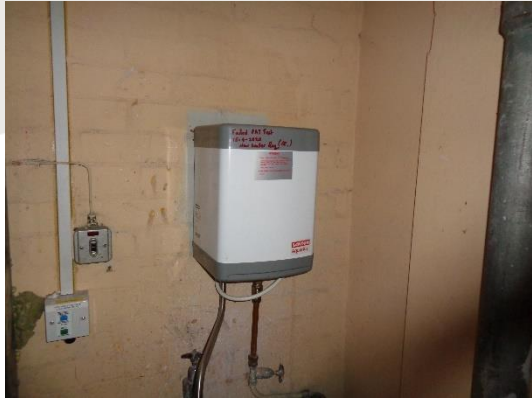
PHOTO REF 01

Report and Photo Reference	Significant findings	Prompt Action Required	Target Date for Remedial Works	Corrective Action Completed	Service area
<b>8.1.1</b> Photo 1	<b>General</b> The water heater in the cleaner's cupboards have out of date PAT labels, 1 heater has been isolated and requires replacement.	Carry out PAT test and supply certificate of testing to all hot water heaters.	9 <sup>th</sup> August 2021		<b>ET</b> <b>(Electrical Team)</b>
<b>8.1.2</b>	<b>General</b> I was unable to locate testing certificates for the Solar PV system and Lightning conductor.	Please provide test certificates.	9 <sup>th</sup> August 2021		<b>ET</b> <b>(Electrical Team)</b>
<b>8.1.3</b> Photo 2	<b>Floor 16;</b> The skylight to the top floor is broken	Works have been raised to replace the skylight according to CRM, post inspection required to ensure completion.	9 <sup>th</sup> August 2021		<b>ST</b> <b>Surveying Team</b>

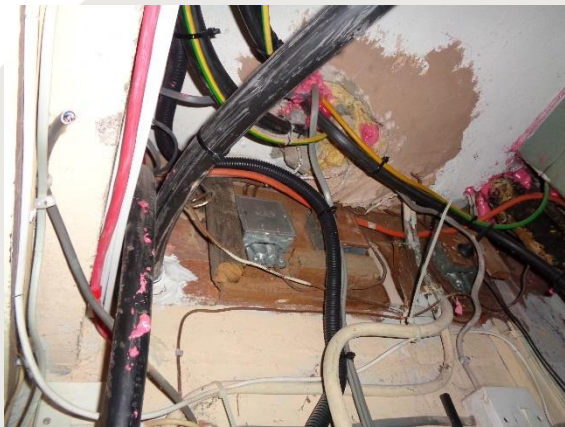
PHOTO REF 03

<b>8.1.4</b> Photo 3	<b>All floors dry-risers and service riser cupboards;</b> The fire stopping (pink foam) is still in place, areas that have been removed have not been repaired satisfactorily.	Make good with suitable and appropriate fire stopping products to all areas.	9 <sup>th</sup> August 2021		<b>PT</b> <b>(Project Team)</b>
<b>8.1.5</b>	<b>Refuse Room</b> The door which allows internal access to the bin chute is a timber door with	Replace the door and frame with a metal FD60s fire door.	9 <sup>th</sup> August 2021		<b>PT</b> <b>(Project Team)</b>

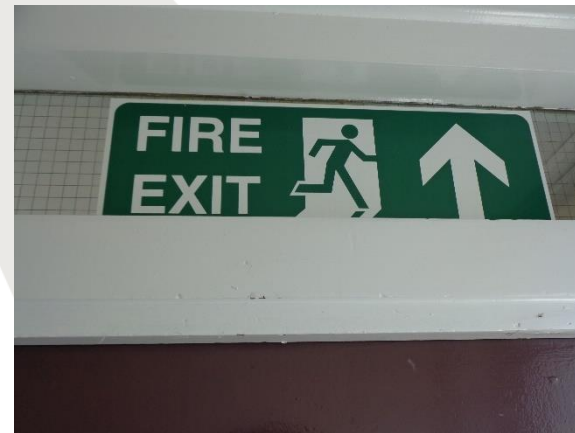
PHOTO REF 04/5

metal mesh to the one side, this is in poor condition				
<b>8.1.6 Photo 4</b>	<b>All Floors;</b> Replace fire exit signs above the stairwell communal doors, all signs indicate escape is upwards.	Replace signs with exit indicated by a downward arrow.	9 <sup>th</sup> August 2021		<b>NIO (Neighbourhood Impact Officers)</b>
<b>8.1.7</b>	<b>Ground floor refuse room</b> Missing thumb turn lock to the external steel door.	Replace thumb turn lock.	9 <sup>th</sup> August 2021		<b>PT (Project Team)</b>
<b>8.1.8 Photo 5</b>	<b>External</b> There are planters fixed to the balconies of the flats.	Advise customers to remove planters.	9 <sup>th</sup> August 2021		<b>TS (Tenancy Services)</b>
