Fire Risk Assessment review 2021

Austin House
Walsall
WS4 2AF

4th June 2021

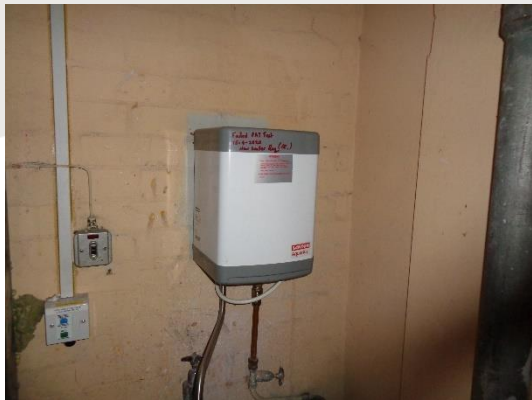
PHOTO REF 01

Report and Photo Reference	Significant findings	Prompt Action Required	Target Date for Remedial Works	Corrective Action Completed	Service area
8.1.1 Photo 1	General The water heater in the cleaner's cupboards have out of date PAT labels, 1 heater has been isolated and requires replacement.	Carry out PAT test and supply certificate of testing to all hot water heaters.	9 th August 2021		ET (Electrical Team)

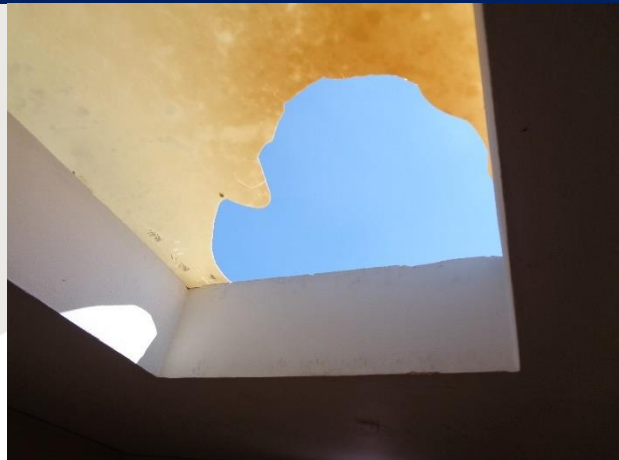
PHOTO REF 02

8.1.3 Photo 2	Floor 16; The skylight to the top floor is broken	Works have been raised to replace the skylight according to CRM, post inspection required to ensure completion.	9 th August 2021		ST Surveying Team

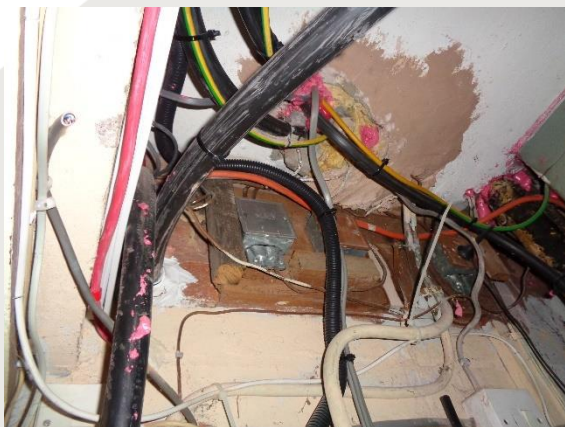
PHOTO REF 03

8.1.4 Photo 3	All floors dry-risers and service riser cupboards; The fire stopping (pink foam) is still in place, areas that have been removed have not been repaired satisfactorily.	Make good with suitable and appropriate fire stopping products to all areas.	9 th August 2021		PT (Project Team)

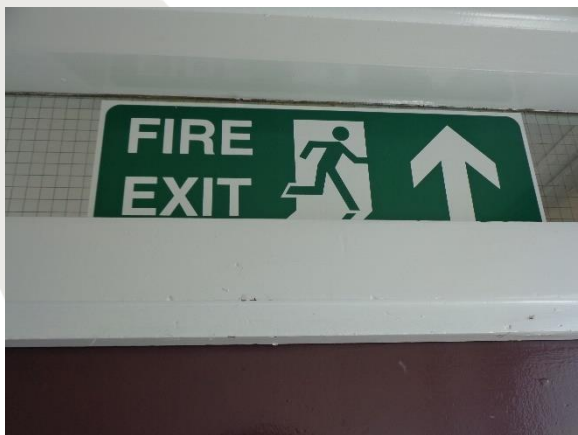
PHOTO REF 04/5

metal mesh to the one side, this is in poor condition				
8.1.6 Photo 4	All Floors; Replace fire exit signs above the stairwell communal doors, all signs indicate escape is upwards.	Replace signs with exit indicated by a downward arrow.	9 th August 2021		NIO (Neighbourhood Impact Officers)
8.1.7	Ground floor refuse room Missing thumb turn lock to the external steel door.	Replace thumb turn lock.	9 th August 2021		PT (Project Team)
8.1.8 Photo 5	External There are planters fixed to the balconies of the flats.	Advise customers to remove planters.	9 th August 2021		TS (Tenancy Services)
