**Fire Risk
Assessment 2021
Review**
Orlando House
Caldmore
WS1 3DX

4th May 2021

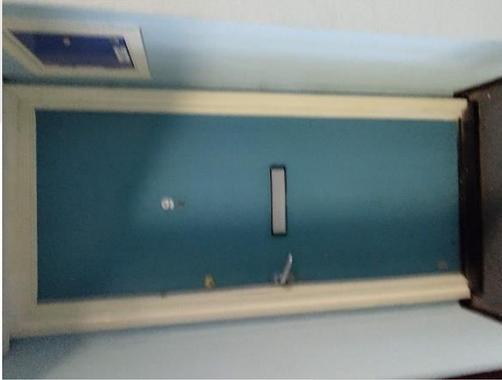
PHOTO REF 01

9.1.2 Photo 1	Floor No 9 The door had to be forced opened by the emergency services.	Replace complete door set with FD30	31 st August 2021		PT (Project Team)
