Fire Risk Assessment

Whiston House
New Street
Walsall
WS1 3DN

07 May 2021 Review

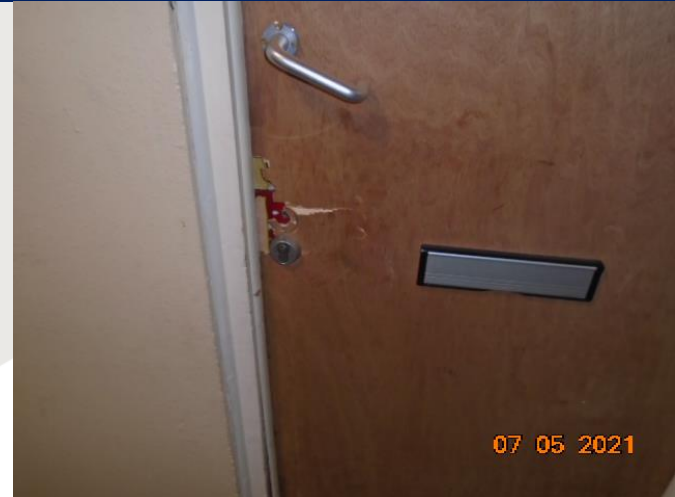
PHOTO REF 03

7.1.4 Image 3	There are several areas of non-fire rated glazing and damaged panes of glass in	The relevant RTL is already aware of this and a second email was sent asking for the glazing to be attended too	20.05.21			Neil Harriman

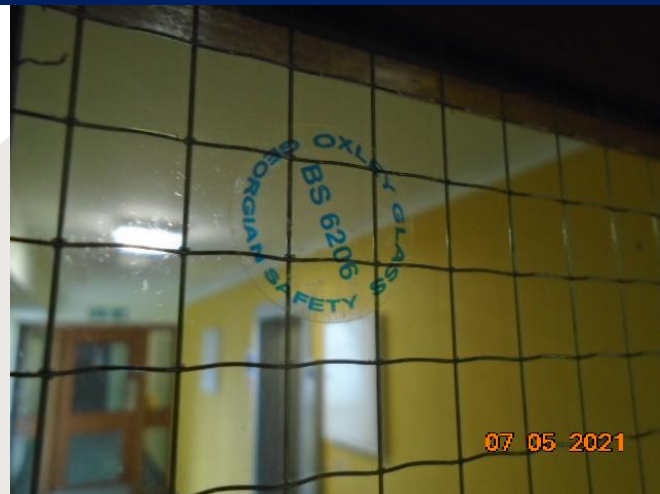
PHOTO REF 04

and 8	the stairwell and lobby door					
7.1.5 Image 4	A polycarbonate sheet has been fitted in the stair well frame by flat 36	The relevant RTL is already aware of this and a second email was sent asking for the glazing to be attended too	20.05.21			Neil Harriman

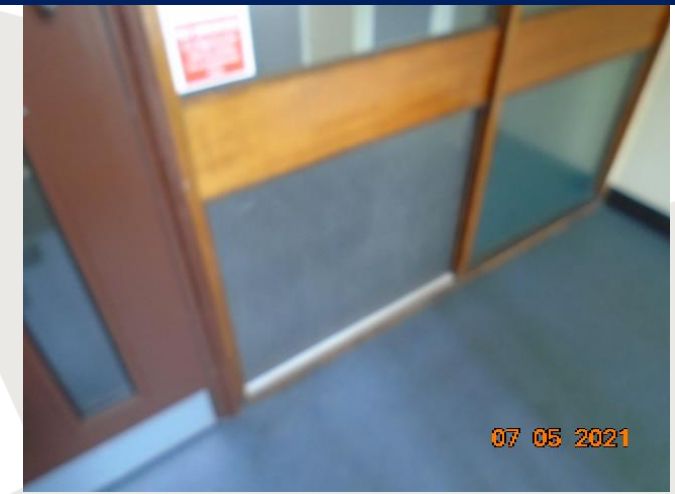
PHOTO REF 05

7.1.6 Image 5	Several books have been left on the main entrance area.	Remove and correctly dispose of the books	20.05.21			NIO
7.1.7 Image 6	2 bags of black of rubbish have been left in the refuse room on the 2 nd floor	Remove and correctly dispose of the black bags	20.05.21			NIO

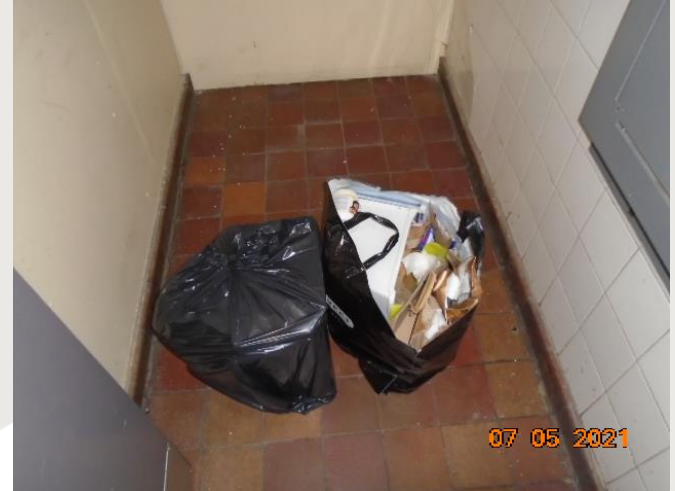
PHOTO REF 07

7.1.8 Image 7	Cigarette butts were evident on the floor that leads to the roof area	Letter all customers to remind that smoking is not allowed within the communal area	20.05.21			TS

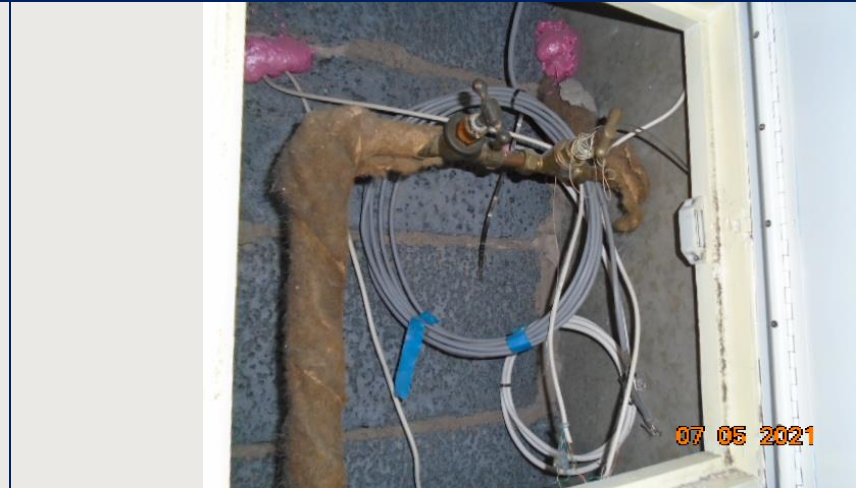
PHOTO REF 11

8.1.3 Image 11	There is an area of missing block work at the top of the stop tap box by flat 38	Use fire retardant batts and mastic to fire proof this breach	26.06.21			PT

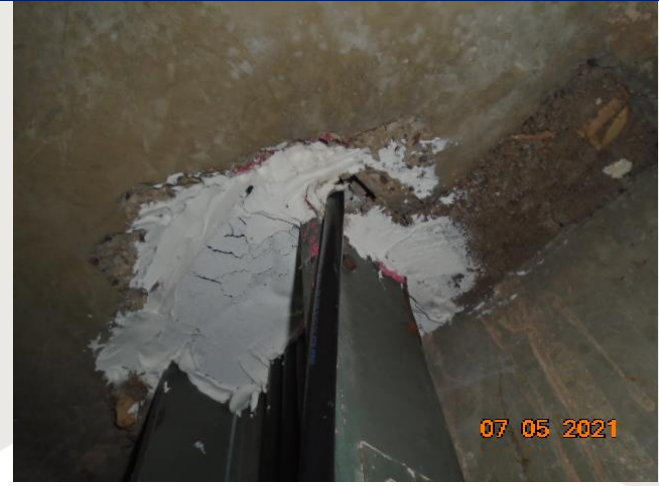
PHOT REF 15

8.1.7 Image 15	There are drill holes in the wall of the electrical services cupboard by flat 28	Fill the holes with suitable fire-retardant mortar or mastic	26.06.21			PT
