Fire Risk Assessment 2020

Jones House
WS2 8JX
North Walsall

First review 12th March 2020

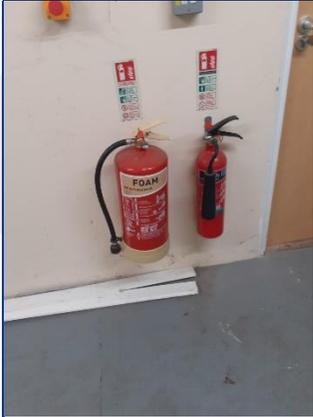
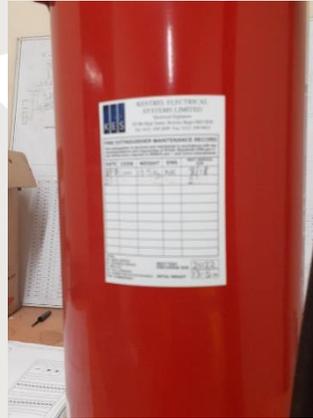
PHOTO REF 001

Reference Photo Report and	Significant findings	Urgent Action Required	Target Date for Remedial Works	Corrective Action Completed	Service area
7.1.1 Photo 1-2	Boiler plant room; The fire extinguishers, CO ² and foam do not have a valid service date.	Arrange servicing and provide certification.	22 nd March 2021		Neighbourhood Contracts

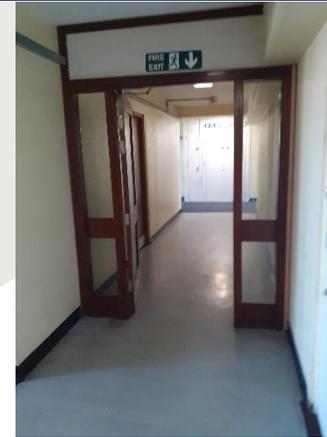
REPORT REF 7.1.2

7.1.2 Photo 3	Ground floor lobby; Both communal doors leading to the individual flats (East/West) are sticking and one was fouling the floor coverings.	Ease and adjust both doors to allow complete closure into the rebated.	22 nd March 2021		Projects Team

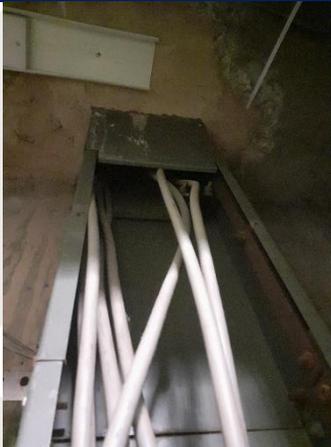
REPORT REF 7.1.4

7.1.4 Photo 4	Floor 4; The steel cover has been removed from the electrical cable ducting in the service cupboard exposing a compartmentation issue between floors.	Install intumescent pillows and sealant before refitting the steel ducting.	22 nd March 2021		Project Team and Electrical Team

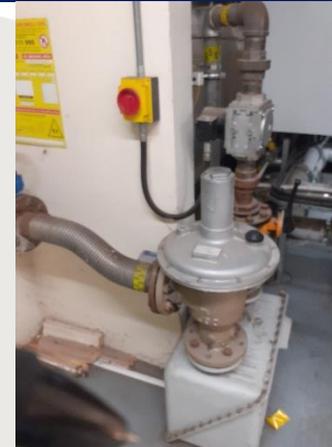
REPORT REF 8.1.1

Reference Photo Report and	Significant findings	Prompt Action Required	Target Date for Remedial Works	Corrective Action Completed	Service area
8.1.1 Photo 5	Boiler plant room; There is no signage to indicate the gas service isolation point in the plant room or externally.	Install appropriate "Gas isolation point" signage	27 th April 2021		Neighbourhood Impact Officers.
8.1.2	Cleaners cupboard; The door has come loose off its top hinge.	Re secure the door	27 th April 2021		Projects Team
8.1.3	Cleaners cupboard; The wall mounted water heater has no PAT test date.	Pat test the appliance.	27 th April 2021		Electrical Team
8.1.4 Photo 6	Ground floor area adjacent to the bin store; Accumulations of rubbish were present on the floor.	Install "Do not leave rubbish in the communal area" make sure it's placed within the bin room/bins.	27 th April		Neighbourhood Impact Officers

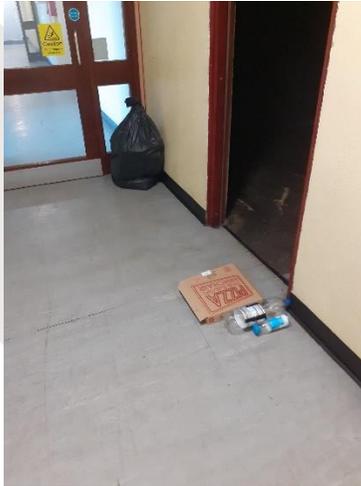
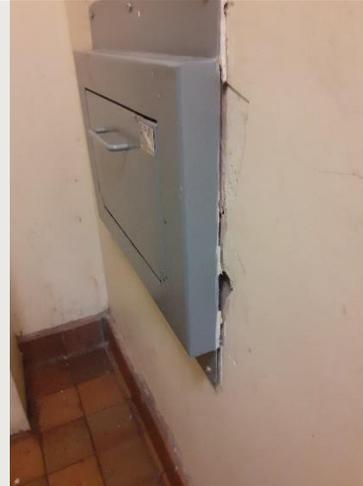
REPORT REF 8.1.10

8.1.9	Floor 1; The stairs door adjacent to flat 12 is not closing correctly.	Re hang and adjust the stairs door	27 th April 2021		Project Team
8.1.10 Photo 7	Floor 6; The chute hopper frame is loose and the seal has broken between the wall frame.	Re secure the chute hopper frame and sealant.	27 th April 2021		Project Team

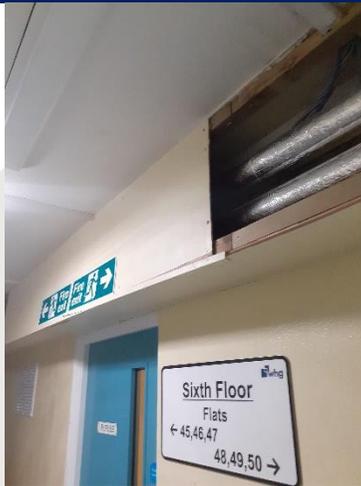
REPORT REF 9.1.5

<p>9.1.5 Photo 11</p>	<p>General to all floors; The heating pipework boxing on the communal area appears to be constructed with softwood battens and plywood sheeting; this will not provide adequate fire protection in the event of a fire and does not conform to Building Regulations B2 6.4 Internal fire spread.</p>	<p>Remove all ply boxing and timber work, install non-combustible class 0 boxing</p> <p>(This action was on the previous 2020 FRA)</p>	<p>18th June 2021</p>		<p>Project Management</p>
<p>9.1.6</p>	<p>General to all floors; There is a large amount of PVCu trunking in the common areas and cabling that is not adequately secured.</p>	<p>Ensure all wiring attached to the boxing conforms to BS7671 2008 (Amendment 3 Chapter 52) "Wiring systems in escape routes shall be supported in such a way that they will not be liable to premature collapse in the event of a fire"</p> <p>Fire clips are to be used both within trunking and where clipped to a wall. Cables must be secured at appropriate intervals by proven metal supports that have adequate fire resistance and fixed to a non-combustible substrate of the building"</p> <p>(This action was on the previous 2020 FRA)</p>	<p>18th June 2021</p>		<p>Project Management</p>
