Fire Risk Assessment 2021

St Giles Court
Willenhall
WV13 2LX

13th May 2021

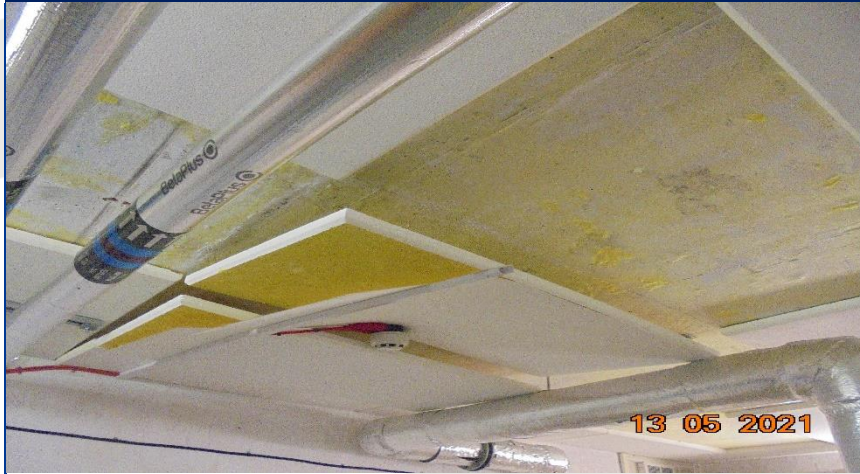
PHOTO REF 01

Report and Photo Reference	Significant findings	Prompt Action Required	Target Date for Remedial Work	Corrective Action Completed	Service area
9.1.1 Photo Ref 01.	Pump Room. Loose insulating panels to the ceiling	Re seal to the ceiling with a fire rated adhesive			PMO
9.1.2	General; Vulnerable customers in the block	Customers to be contacted to arrange PEEPS – personal emergency evacuation plan – contact surveyor for more information.			TS

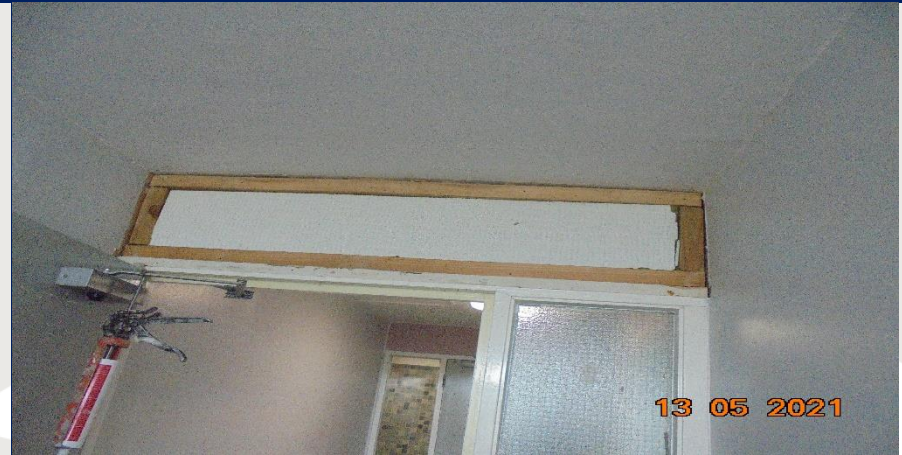
PHOTO REF 02

NB – Block is currently undergoing refurbishment works to the protected stair well fire doors, with fire rating insulation and boarding – photo 02
