Fire Assessment 2021

12th May 2021

St Annes Court
Willenhall
WV13 2LY

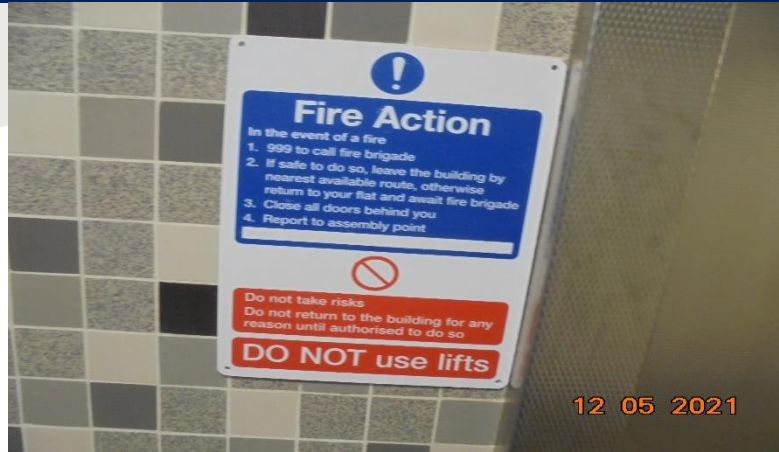
PHOTO REF 01

Report and Photo Reference	Significant findings	Prompt Action Required	Target Date for Remedial Work	Corrective Action Completed	Service area
8.1.1 Photo ref. 01	General; No assembly point on the action plan	Provide a designated assembly point on the action plan			NIO
8.1.2 Photo ref. 02	General; Contractors items in electrical cupboard	Remove contractors' items from the electrical cupboard floor 6			PMO
8.1.3 Photo ref. 03	General; Rubbish in the protected stairwell	Remove all items and investigate to whom is leaving items			NIO/TS
8.1.4 Photo ref.04	General; Hole to the electrical cupboard	Seal hole with an intumescent sealant to the wall			PT
